## **VIDEO ENTERTAINMENT SYSTEM DIAGNOSTIC MANUAL**

Rev: B 12/17/01

# TOYOTA SIENNA 2001 – VIDEO ENTERTAINMENT SYSTEM

Service Diagnostic Manual

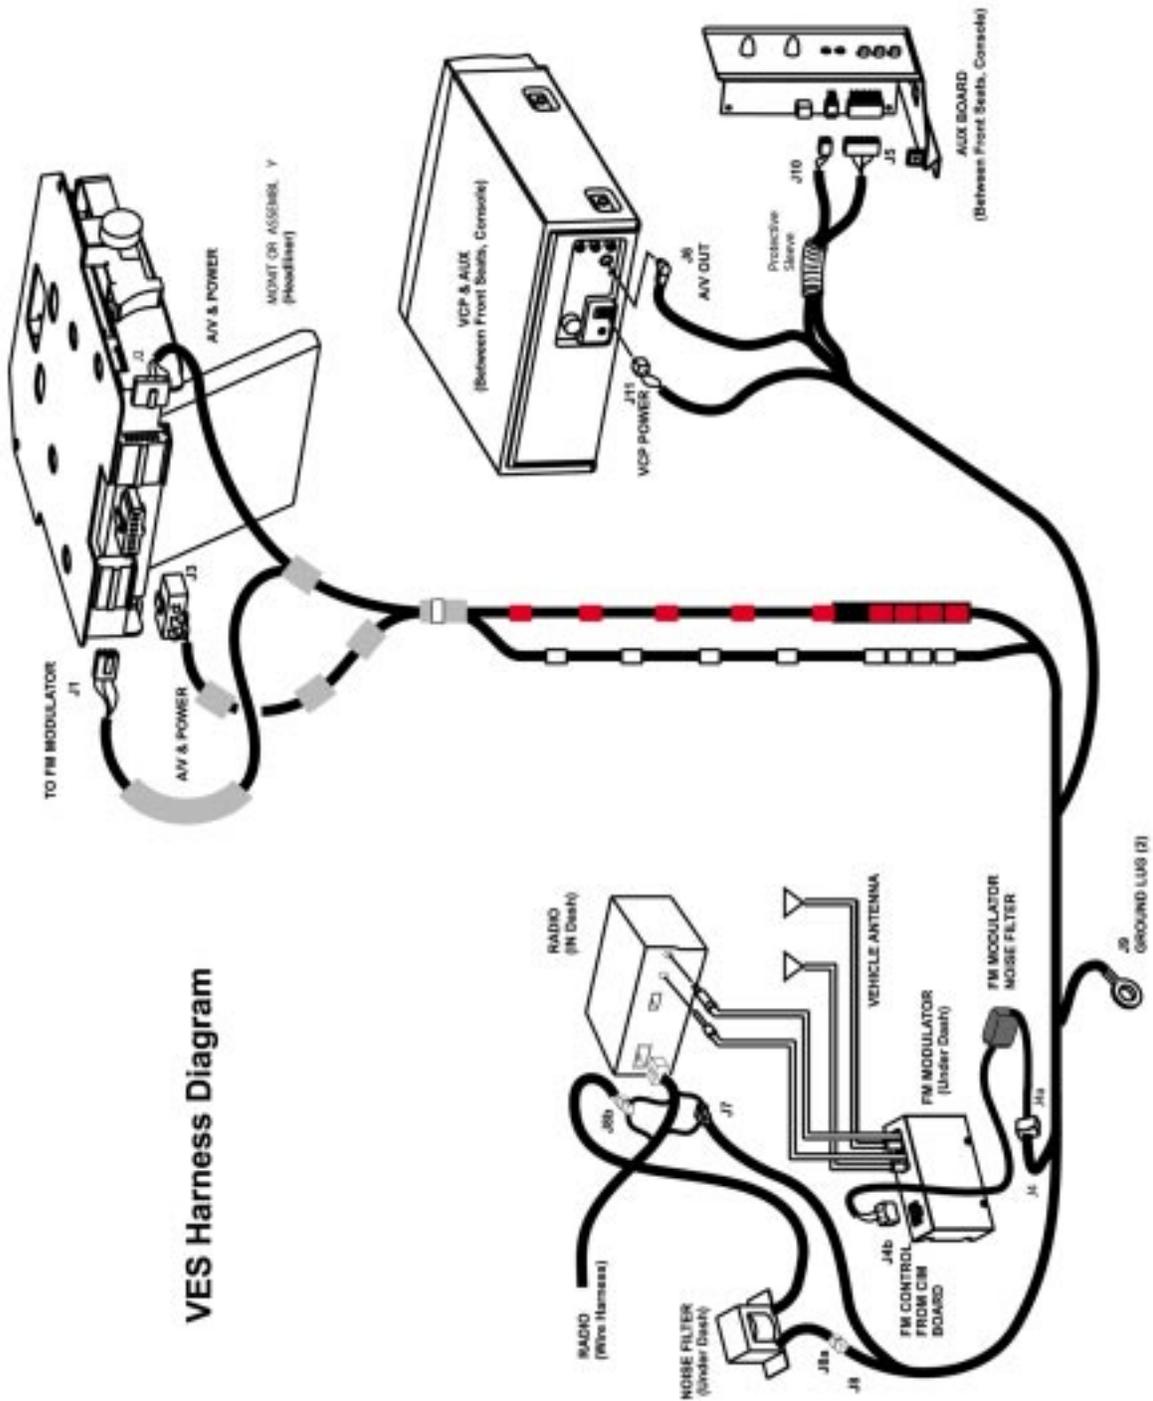
## Sienna VES Component and Harness Map

VES Harness Diagram

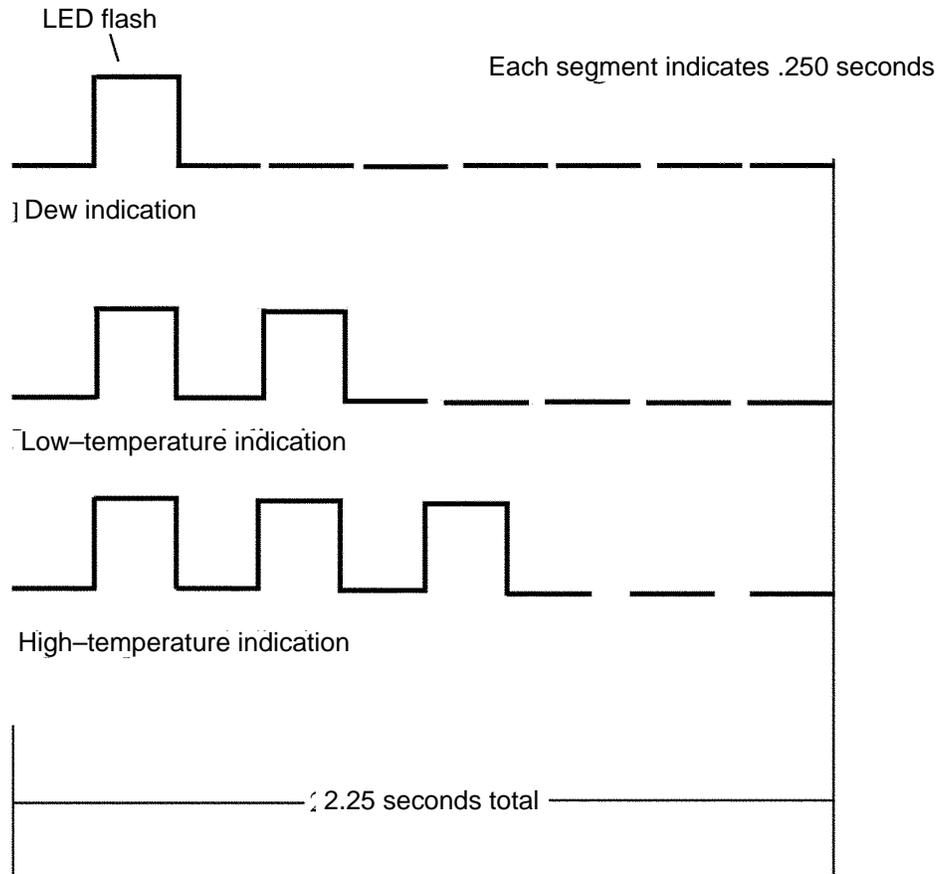
The Status LED flashes in groups of one, two, or three flashes to communicate what error conditions are present. These error conditions are:

**One flash** – “Dew” or moisture present in the video cassette player.

**Two flashes** – A low-temperature condition. This means below 0° C/32° F.

**Three flashes** – A high-temperature condition. This means over 60° C /140° F.

Location of the  
Status LED

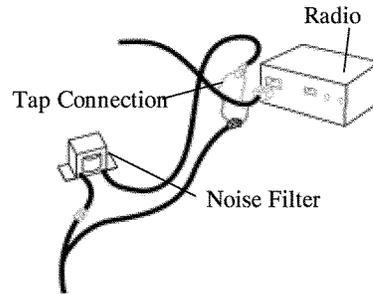
Tap Connection

**Note:** Assure that the two wires are properly connected: BLU/YEL of VES to BLU/YEL of the radio harness, GRY of VES to GRY of the radio harness. Reversal of these connections will cause apparent system failure. Also assure that both filter wires are connected firmly.

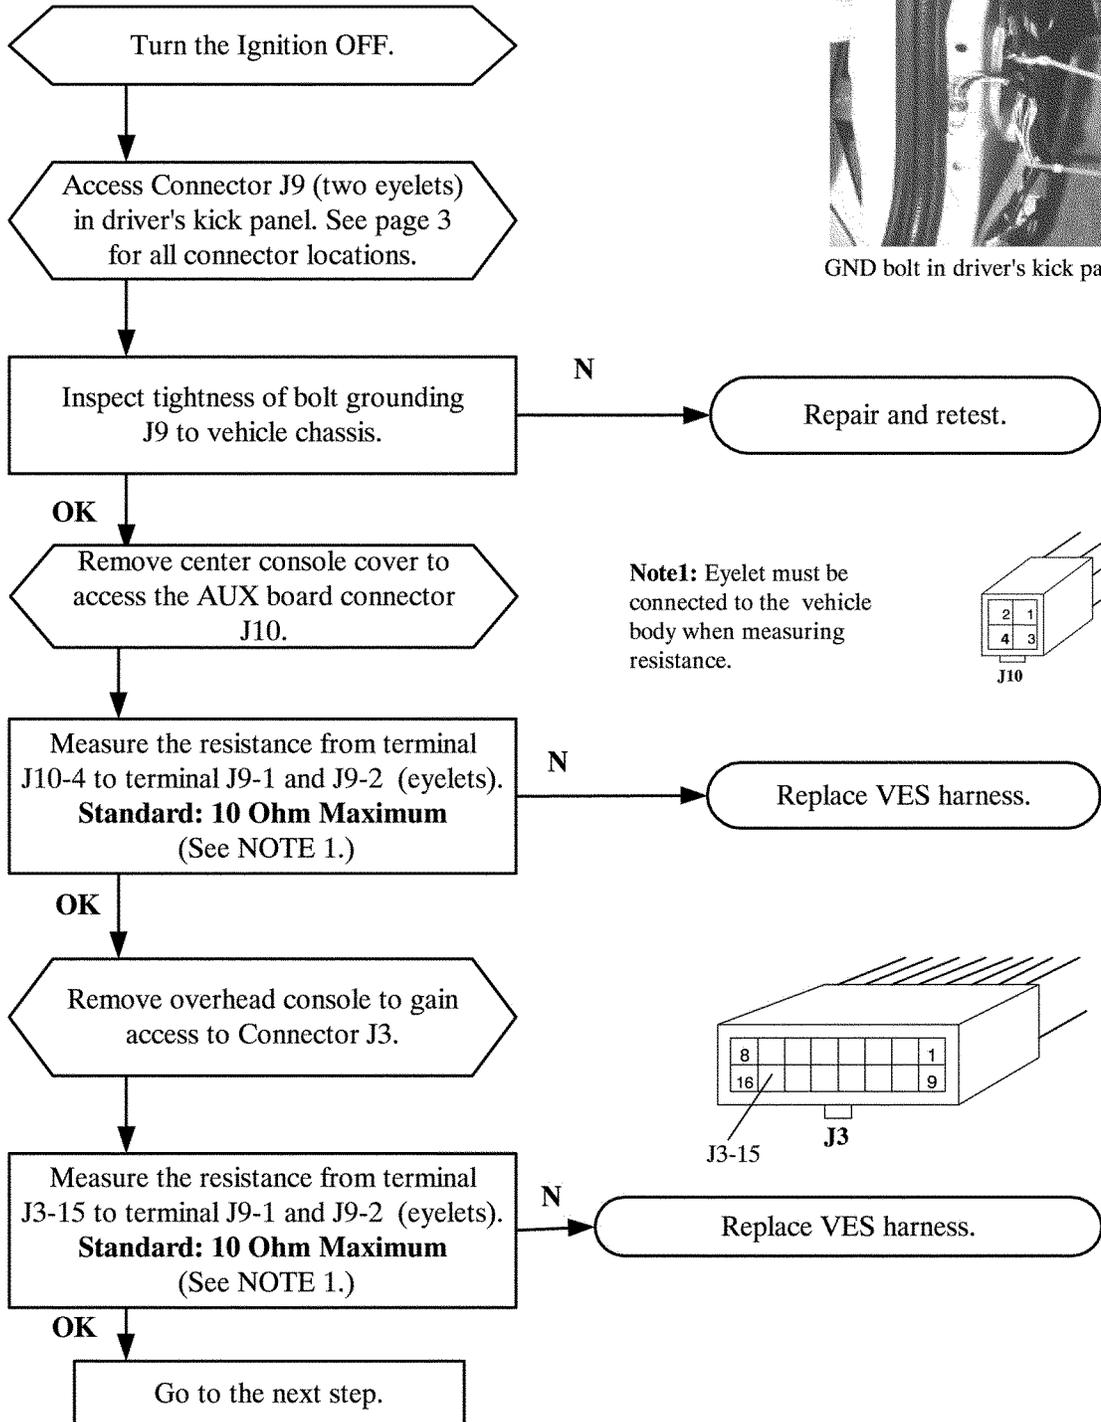
## Check 3: VES Harness Ground Check

GND bolt in driver's kick panel

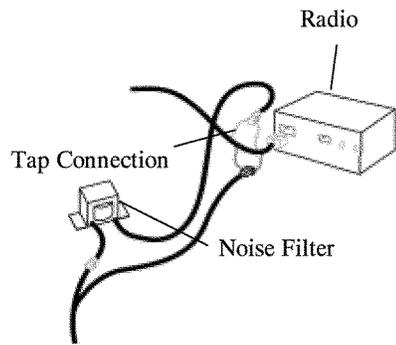
Tap Connection

**Note:** Assure that the two wires are properly connected: BLU/YEL of VES to BLU/YEL of the radio harness, GRY of VES to GRY of the radio harness. Reversal of these connections will cause apparent system failure. Also assure that both filter wires are connected firmly.

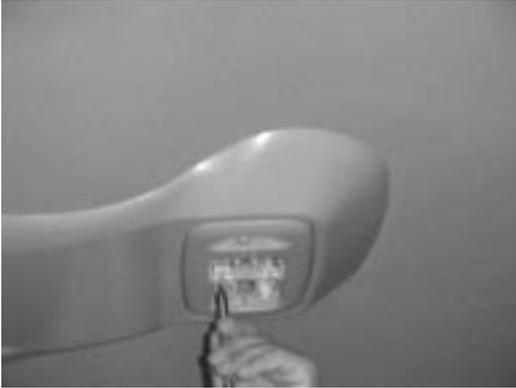
**1 REMOVE DOME LIGHT**

- (a) Remove both lens covers
- (b) Remove the two (2) Phillips dome light mounting screws

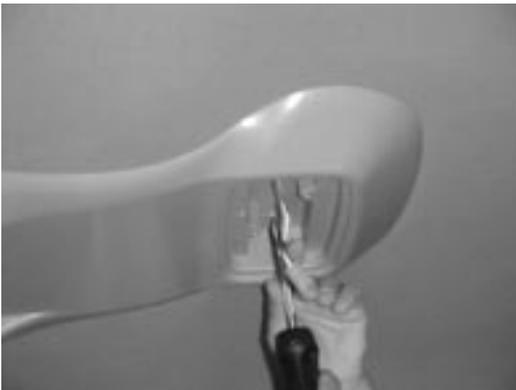
**2 REMOVE OVERHEAD CONSOLE SCREWS**

- (a) Disconnect wire harness from dome light
- (b) Remove the two (2) Phillips rear console mounting screws

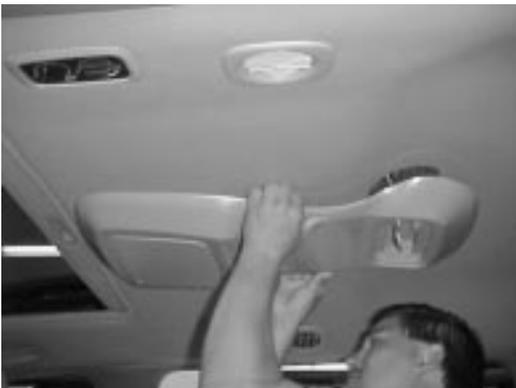
**3 REMOVE MONITOR ASSEMBLY**

- (a) Carefully pull overhead console down. The front of the console is mounted with six (6) clips – make sure to disengage all of these clips

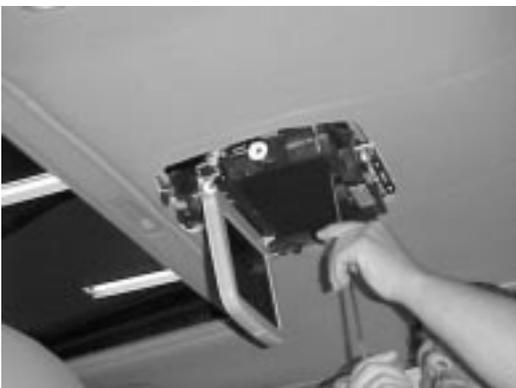
**4 FLAT PANEL DISPLAY/ELECTRONICS REMOVAL**

- (a) Remove the four (4) Allen screws in the FPD assembly, using a long 4mm Allen wrench
- (b) Screws are located two (2) at front and two (2) at rear

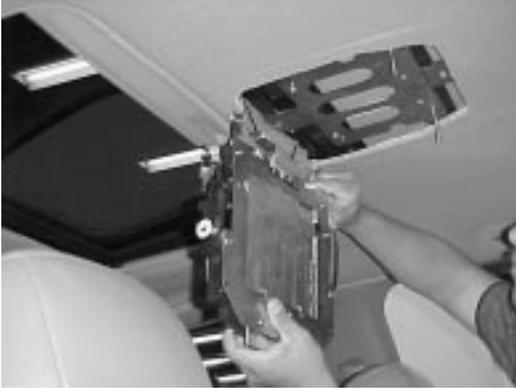
## **5 WIREHARNES DISCONNECTION**

- (a) Disconnect all three (3) harnesses from the monitor assembly
- (b) This may require two persons, one to hold the assembly and one to unplug the connections
- (c) The assembly is now free to remove

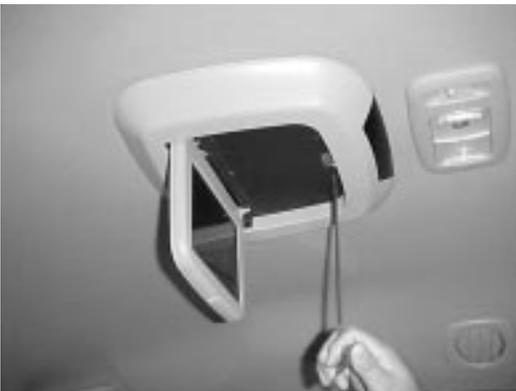
## **1 FLAT PANEL DISPLAY/ELECTRONICS REMOVAL**

- (a) Carefully pull overhead console down. It is mounted with six (6) clips – make sure to disengage all of these clips
- (b) Remove the four (4) Allen screws in the FPD assembly using a long 4mm Allen wrench
- (c) Screws are located two (2) at front and two (2) at rear
- (d) Drop assembly from headliner and disconnect the 3 connectors
- (e) Disconnect all three (3) harnesses from the monitor assembly
- (f) This may require two persons, one to hold the assembly and one to unplug the connections
- (g) The assembly is now free to remove

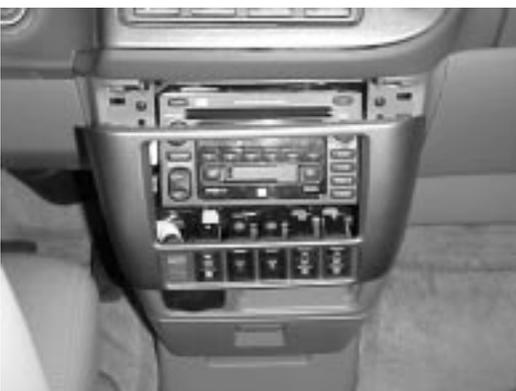
## **1 REMOVE RADIO**

- (a) Remove bezel from around radio
- (b) Disconnect connectors from bezel
- (c) Remove four (4) screws and pull radio
- (d) Disconnect antenna lead and harness from rear of radio

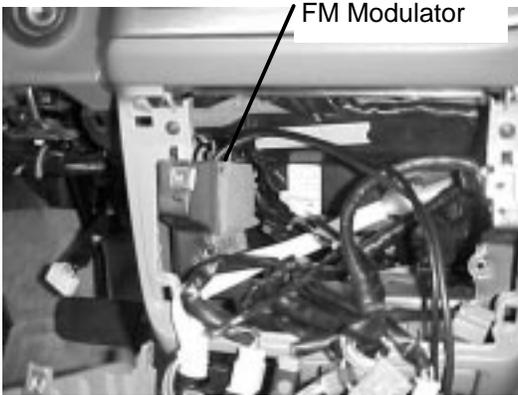
**2 REMOVE FM MODULATOR**

- (a) Locate FM Modulator
- (b) Remove wire ties holding FM Modulator
- (c) Disconnect wire harness from FM Modulator

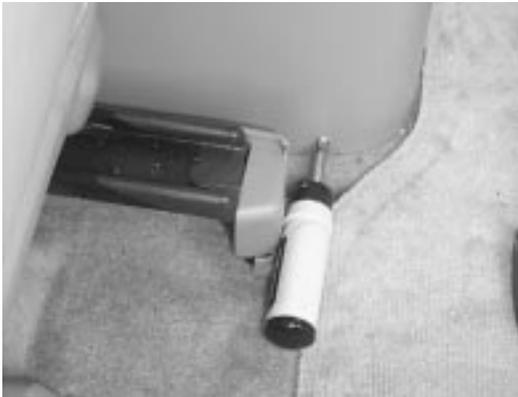
**1 REMOVE SIDE SCREWS**

- (a) Remove left and right side Phillips screws from rear of console

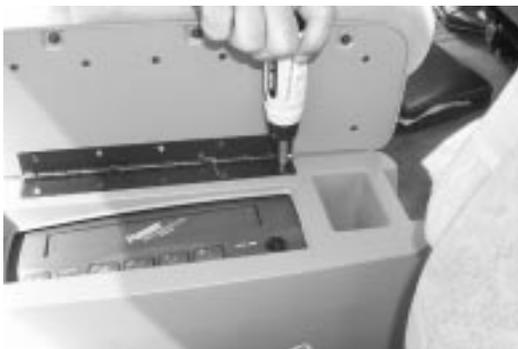
**2 REMOVE HINGE SCREWS**

- (a) Remove the two (2) outer Phillips screws on the hinge

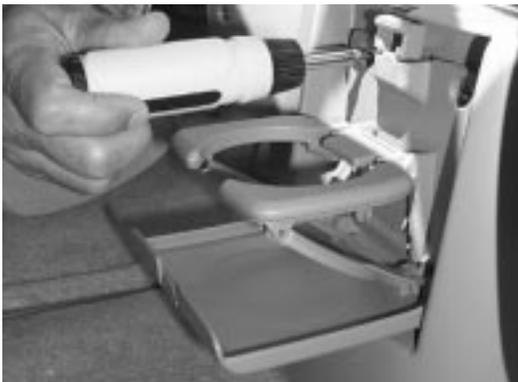
**3 REMOVE CUP HOLDER SCREWS**

- (a) Remove the two (2) Phillips screws on the bottom cup holder, and remove cup holder

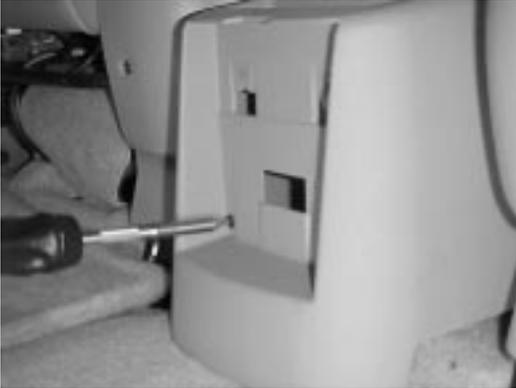
**4 REMOVE FRONT SCREWS**

- (a) Remove two (2) screws from behind the cup holder
- (b) Slowly lift console box upward and out from between the seats

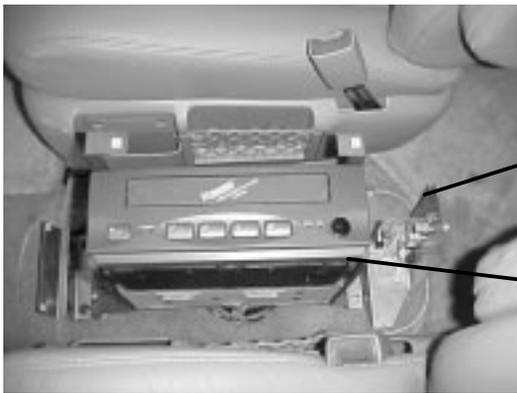
**1 COMPONENTS**

Jack Plate

VCP

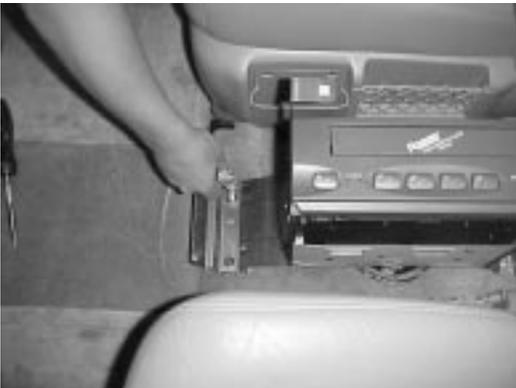
**2 REMOVE VCP FRONT SCREWS**

- (a) Remove two (2) Phillips screws at front of VCP

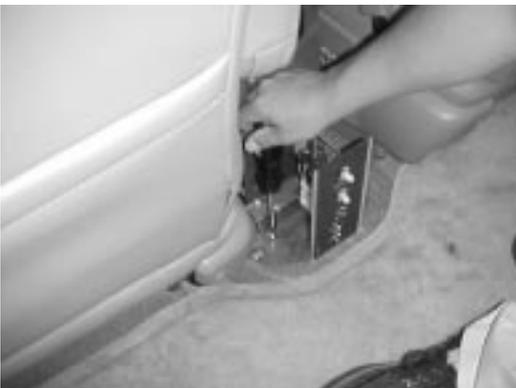
**4 REMOVE VCP FROM BRACKET ASSEMBLY**

- (a) Remove four (4) Phillips screws from bracket assembly
- (b) Disconnect J11 and J6 connectors and remove VCP from bracket assembly
